### LBP Assessment Results

# Property ID # 437 / 3642 Humboldt Street

This spreadsheet performs screening level calculations to estimate the effect of peeling leaded paint on the average concentration of lead in yard soil 3642 Humboldt Street

### U.S. Environmental Protection Agency Vasquez Boulevard I/70 Superfund Site Replacement Certificate

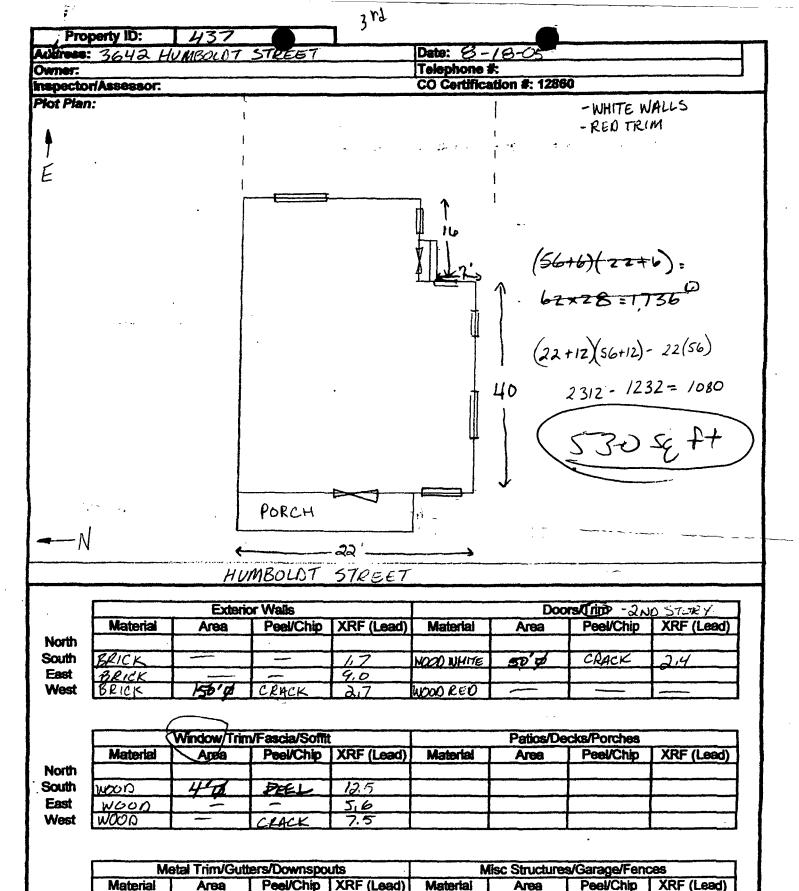
Site	Component	Substrate	Side	Condition	Color	Floor	Room	Results	Depth Inde	PbC	PbC Error
8/18/2005 10:18			CONCRETE	WEST	CRACKED	PURPLE	FIRST	PORCH	Negative	2.78	0.03	0.03
8/18/2005 10:19	437	EXT. WALL	BRICK	WEST	CRACKED	WHITE	FIRST	OUTSIDE	Positive	5.33	2.7	0.5
8/18/2005 10:20		WINDOW FRAME	WOOD	WEST	CRACKED	WHITE		OUTSIDE		6.95	7.5	1.1
8/18/2005 10:21			CONCRETE	WEST	CRACKED	WHITE	FIRST	OUTSIDE	Negative	10	0.3	0.29
8/18/2005 10:22				SOUTH	CRACKED	WHITE	FIRST	OUTSIDE	Positive	2.57	1.7	0.6
8/18/2005 10:23		WINDOW FRAME	WOOD		CRACKED		FIRST	OUTSIDE	Positive	4.17	12.5	1.5
8/18/2005 10:24	437	EXT. WALL	BRICK	EAST	CRACKED	WHITE	FIRST	OUTSIDE	Positive	3.38	9	1.3
8/18/2005 10:25	437	WINDO FRAME	WOOD	EAST	CRACKED	WHITE	FIRST	OUTSIDE	Positive	5.7	5.6	1
8/18/2005 10:27	437	STEP	CONCRETE	SOUTH	PEELING	WHITE	FIRST	OUTSIDE	Negative	5.14	0.03	0.05
8/18/2005 10:29	437	TRIM	WOOD	SOUTH	CRACKED	WHITE		OUTSIDE		2.51	2.4	0.7

8/18/2005 10:31	437	TRIM	MOOD	WEST	CRACKED	PURPLE	SECOND	OUTSIDE	Negative	3.24	0.6	0.1
1												
* *		,										
Note: Readings a	re in mg	g/cm²		<del></del>			<u> </u>					
				<del></del>								
Painted surfaces	not test	ed were assessed	to be in "inta	ct" cond	ition at time	of site vis	it.			1		<del></del>

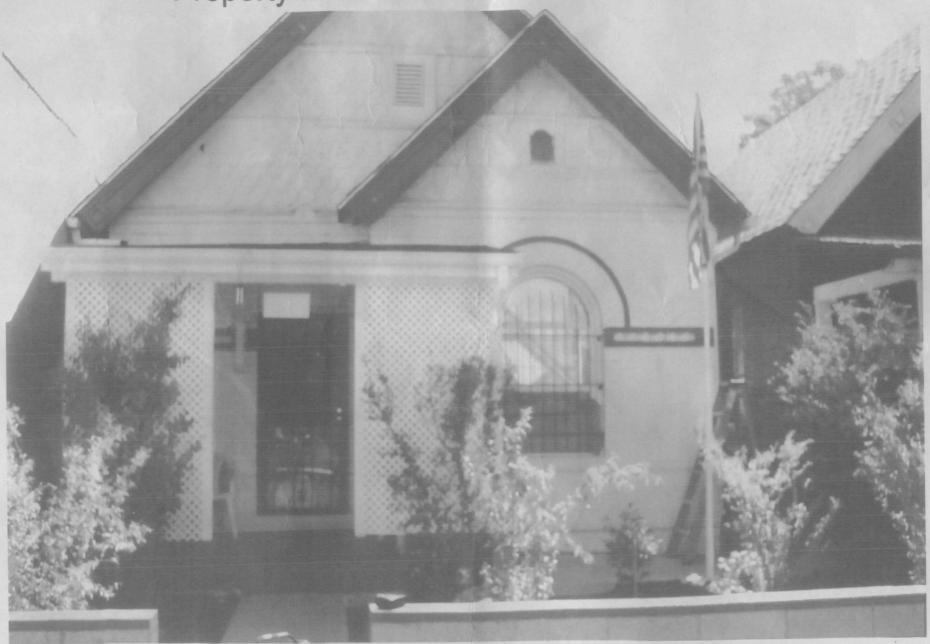
West exposure of house

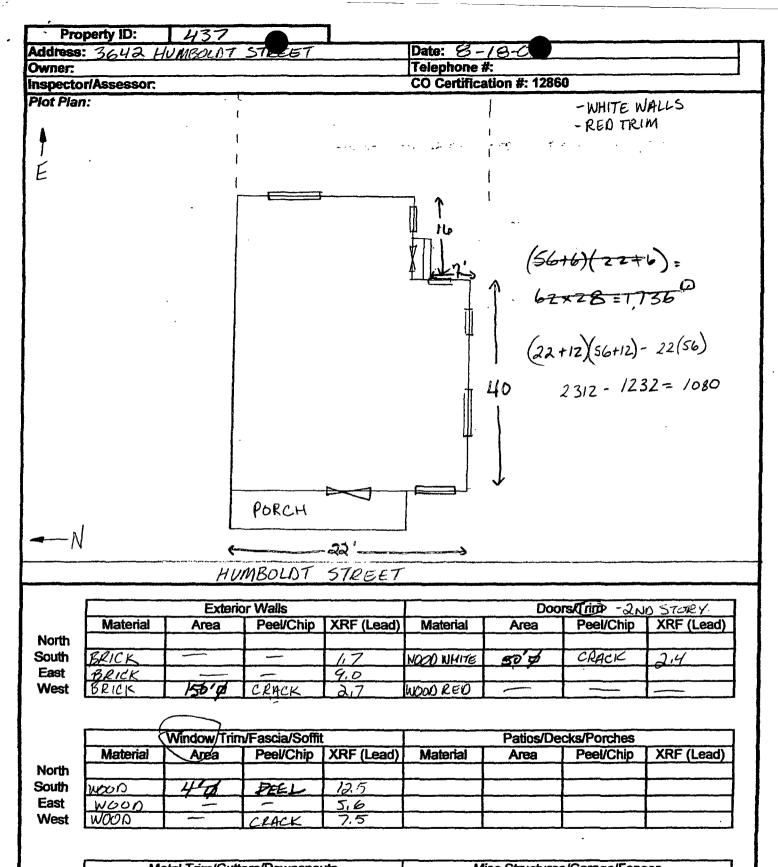
### LBP Assessment Results

Metal I rim/Gutters/Downspouts			Misc Structures/Garage/Fences				
Material	Area	Peel/Chip	XRF (Lead)	Material	Area	Peel/Chip	XRF (Lead)
	* # #			tyre to see			
	<del></del>

R CONCRETE WALL BRICK OW FRAME WOOD OW SILL CONCRETE WALL BRICK OW FRAME WOOD WALL BRICK	WEST WEST WEST SOUTH	CRACKED CRACKED CRACKED CRACKED	WHITE WHITE	FIRST FIRST	OUTSIDE OUTSIDE		2.78 5.33 6.95	0.03 2.7 7.5	0.03 0.5
OW FRAME WOOD OW SILL CONCRETE WALL BRICK OW FRAME WOOD	WEST WEST SOUTH	CRACKED CRACKED	WHITE	FIRST	OUTSIDE		l		
OW SILL CONCRETE WALL BRICK OW FRAME WOOD	WEST SOUTH	CRACKED				Positive	6.95	7.5	4 4
WALL BRICK OW FRAME WOOD	SOUTH		WHITE	FIRST			0.00	7.5	1.1
OW FRAME WOOD		CRACKED		ן וויסווון	OUTSIDE	Negative	10	0.3	0.29
	COLITI		WHITE	FIRST	OUTSIDE	Positive	2.57	1.7	0.6
MALL PRICK	SOUTH	CRACKED	WHITE	FIRST	OUTSIDE	Positive	4.17	12.5	1.5
	EAST	CRACKED	WHITE	FIRST	OUTSIDE	Positive	3.38	9	1.3
O FRAME WOOD	EAST	CRACKED	WHITE	FIRST	OUTSIDE	Positive	5.7	5:6	•
CONCRETE	SOUTH	PEELING	WHITE	FIRST	OUTSIDE	Negative	5.14	0.03	0.0
WOOD	SOUTH	CRACKED	WHITE	SECOND	OUTSIDE	Positive	2.51	2.4	0.
MOOD	WEST	CRACKED	PURPLE	SECOND	OUTSIDE	Negative	3.24	0.6	0.

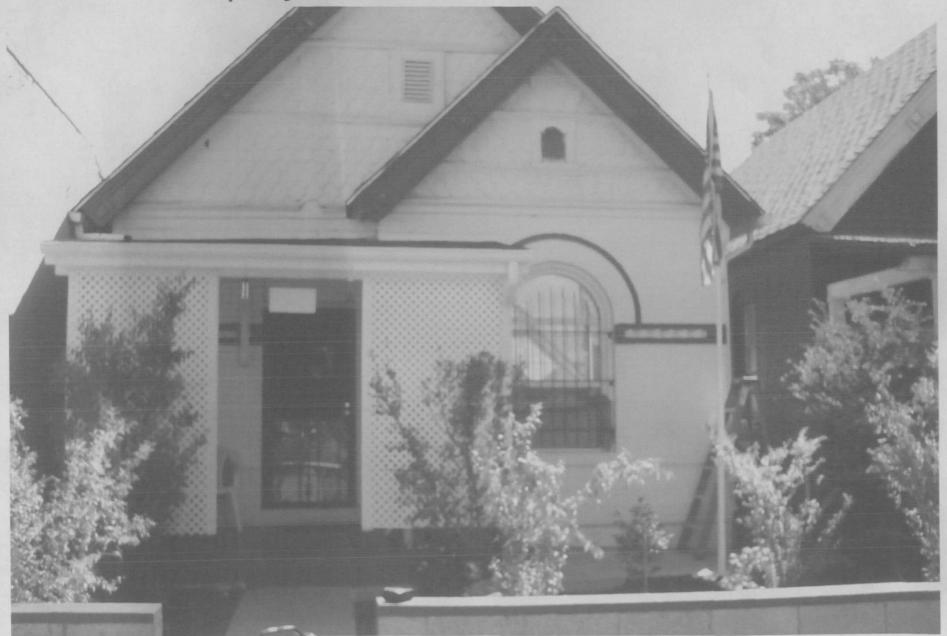
### Property ID # 437 / 3642 Humboldt Street

West exposure of house
